1. REPORT DATE		2. REPORT TYPE Professional Paper		3. DATES COVERED	
4. TITLE AND SUBTITLE Development and Testing of the F/A-18 Replacement MIL-STD-1760 Umbilical				5a. CONTRACT NUMBER	
				5b. GRANT NUMBER	
				5c. PROGRAM ELEMENT NUMBER

Development and Testing of the F/A-18 Replacement MIL-STD-1760 Umbilical¹

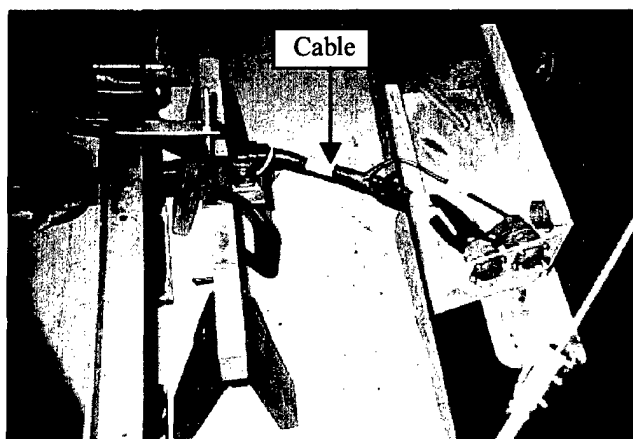
Figure 2 Photograph of Lightning Test Setup

The lightning testing were performed on 2 samples of the umbilical cables with composite connectors and 2 samples of umbilical cables with other connectors. The cable was connected to the mating connectors mounted on a plate (approximately 4 in x 4 in x 0.25 in) and a test fixture as used in the F/A-18 aircraft as shown in Figure 2. Test

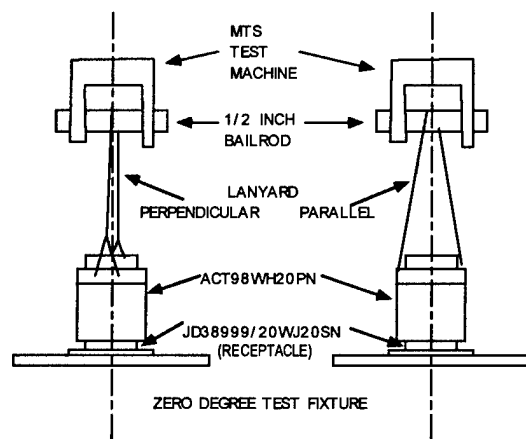
Figure 4 Composite MIL-STD-1760 Connector Static Test Setup

The static test was designed to systematically test six connectors at pull angles ranging from 0° to 15° in 5° increments in both the pitch and roll directions. Each connector was pulled at a fixed rate of 1.6 in/s for 10 times at 0, 5, 10, and 15° and then as time permitted, pulled at 17, 18, and 20°. The test setup, shown in Figure 4, used a MTS test machine with an adapter plate to which the receptacle was mounted. The plate could be adjusted in orientation for both the angle to the vertical and the rotation of the mount. The pull angles were set by tilting the mounting fixture while the pull force was measured using a force transducer attached to the MTS machine.

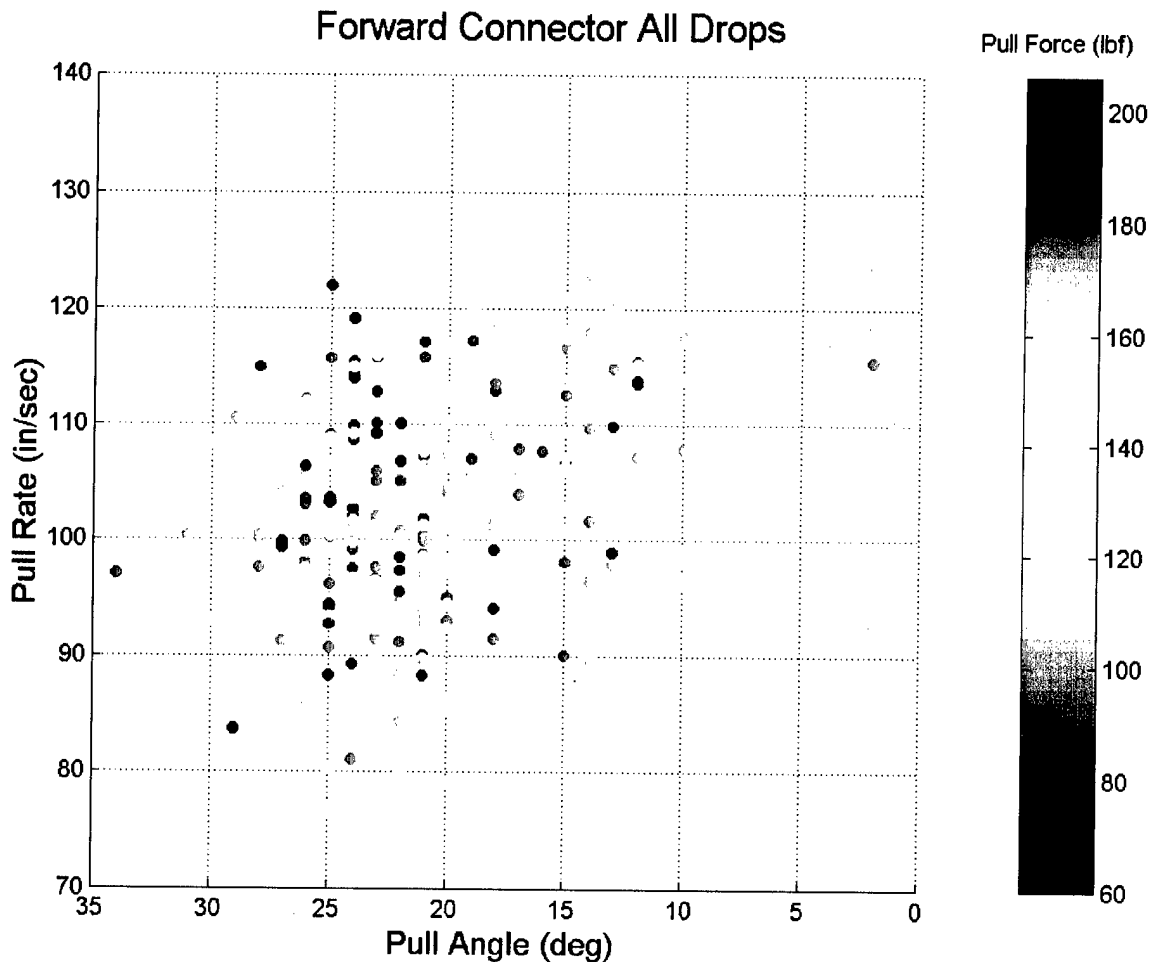
Figure 11 Scatter plot of Pull Force, Pull Rate, and Pull Angle

vertical position prior to connector release. During these ejected release tests, the connector was released with pull angles ranging from 1° to 34° and at a pull rate ranging from 75 in/s up to 135 in/s. The maximum pull force at the forward receptacle was 206 lbf at a 27° pull angle. The minimum pull force was 60 lbf at a 25° pull angle. This shows, along with the histogram plot in Figure 10 and the 3-D scatter plot of pull force, pull rate, and pull angle in Figure 11 that the pull force is a random function of the pull angle. This is contrary to what was expected. Common thought was that as the pull angle increased, the pull force also increased. The data collected from this test shows that this is not the case for this connector. The inability to constrain pull angles to 15° or to smoothly develop the pull force or angle with a bail bar arrangement is significant and should be understood when comparing this data with the qualification standard. Ejected releases typically show higher pull forces overall than static releases and a wider spread of values. In future efforts, expected pull force characteristics should be empirically determined with a statistically significant number of releases.
